***FY2020***  
***HAZARDOUS WASTE***  
***MANAGEMENT FUND***  
***A Report to the General Assembly***

**KENTUCKY ENERGY &  
ENVIRONMENT CABINET**

*Department for Environmental Protection*  
*Division of Waste Management*  
502-564-6716  
[waste.ky.gov](http://waste.ky.gov)

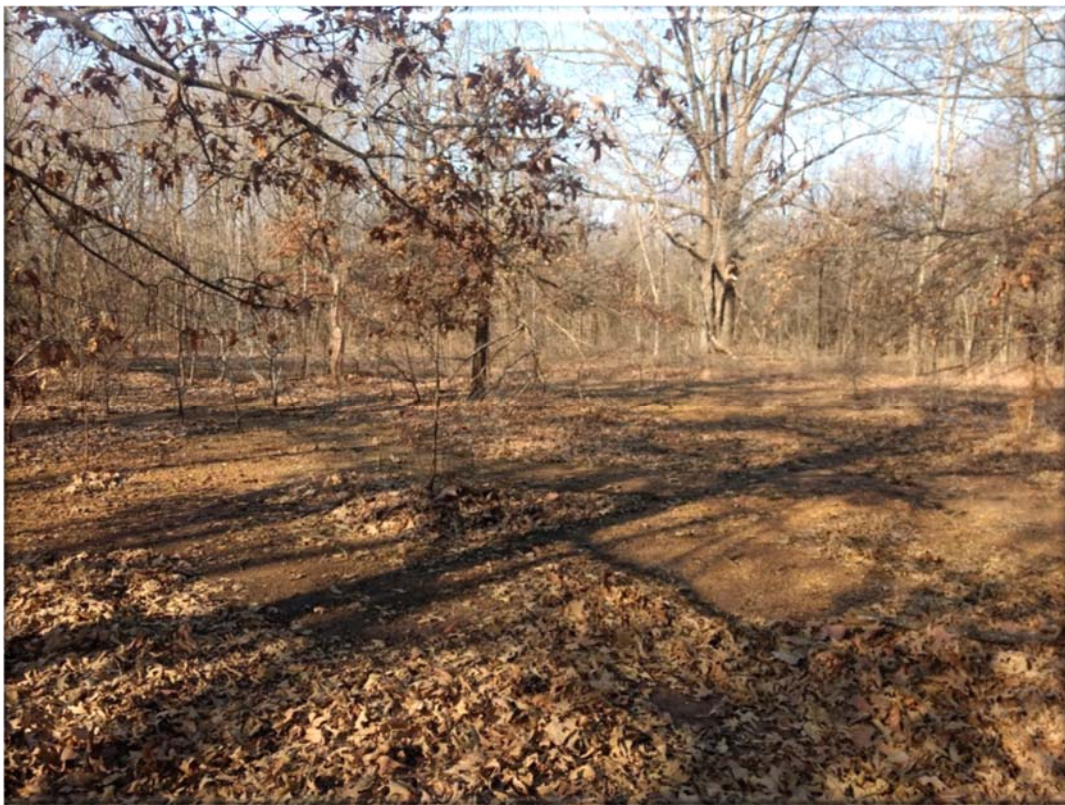
*WKWMA wire burn site, former wire burn locations (bare areas).*

This site is located within the WKWMA. During the early 2000s, KY Fish & Wildlife employees reported several barren areas within a wooded portion of the WKWMA. These areas were littered with small pieces of various debris including metal fragments, broken glass, and ceramic insulators. This appearance suggested that wire and other electrical equipment were burned in the past for recovery of copper. Soil samples collected by the cabinet detected elevated concentrations of several metals, notably lead, as well as polychlorinated biphenyls (PCBs).

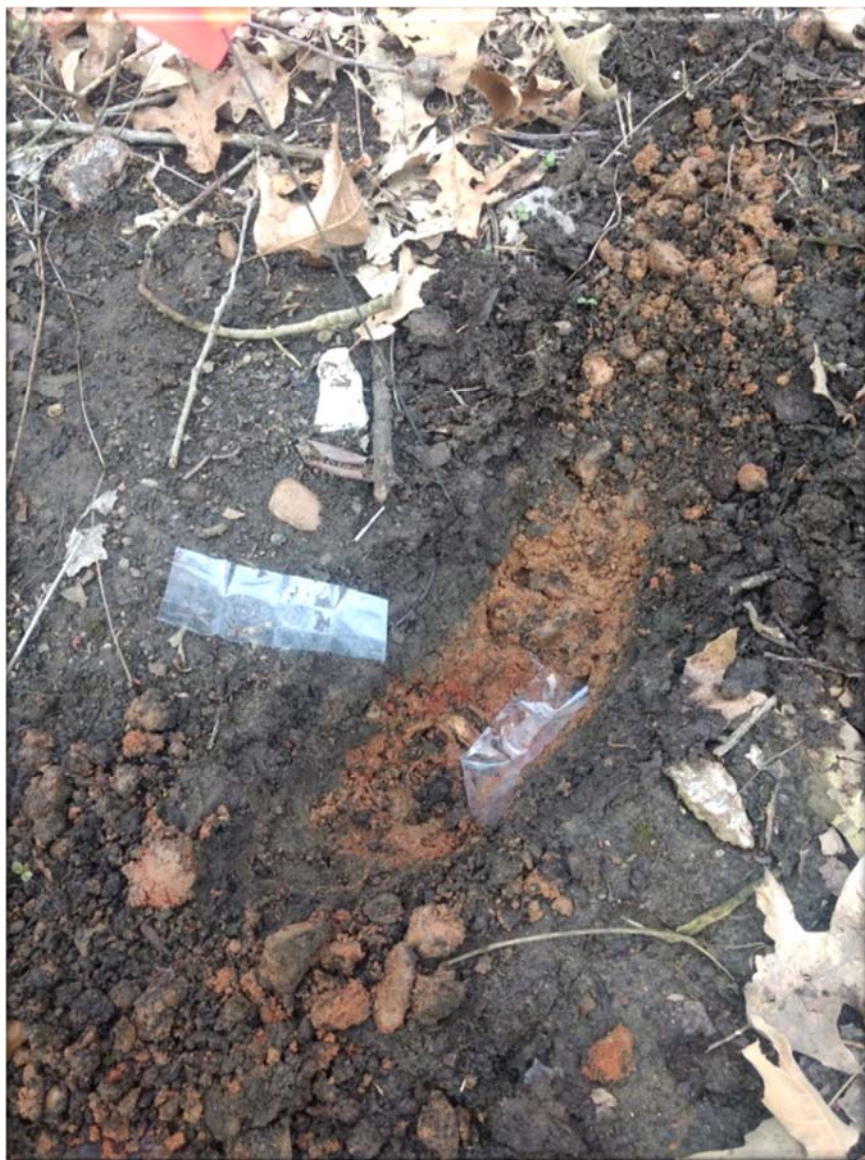
*A test excavation reveals a contrast between highly contaminated surface soils (darker color) and “clean” (lighter color) soil beneath. Pieces of plastic are used to keep the XRF unit clean between screening locations.*

The Superfund Branch (SFB) used its X-Ray Fluorescence (XRF) units to determine the horizontal and vertical extent of the contamination. An XRF allows real-time measurements of metals concentrations in soil. The Branch's investigation has determined the contaminated areas total just over 1.5 acres. Fortunately, the contaminants extend only a few inches below the ground surface.

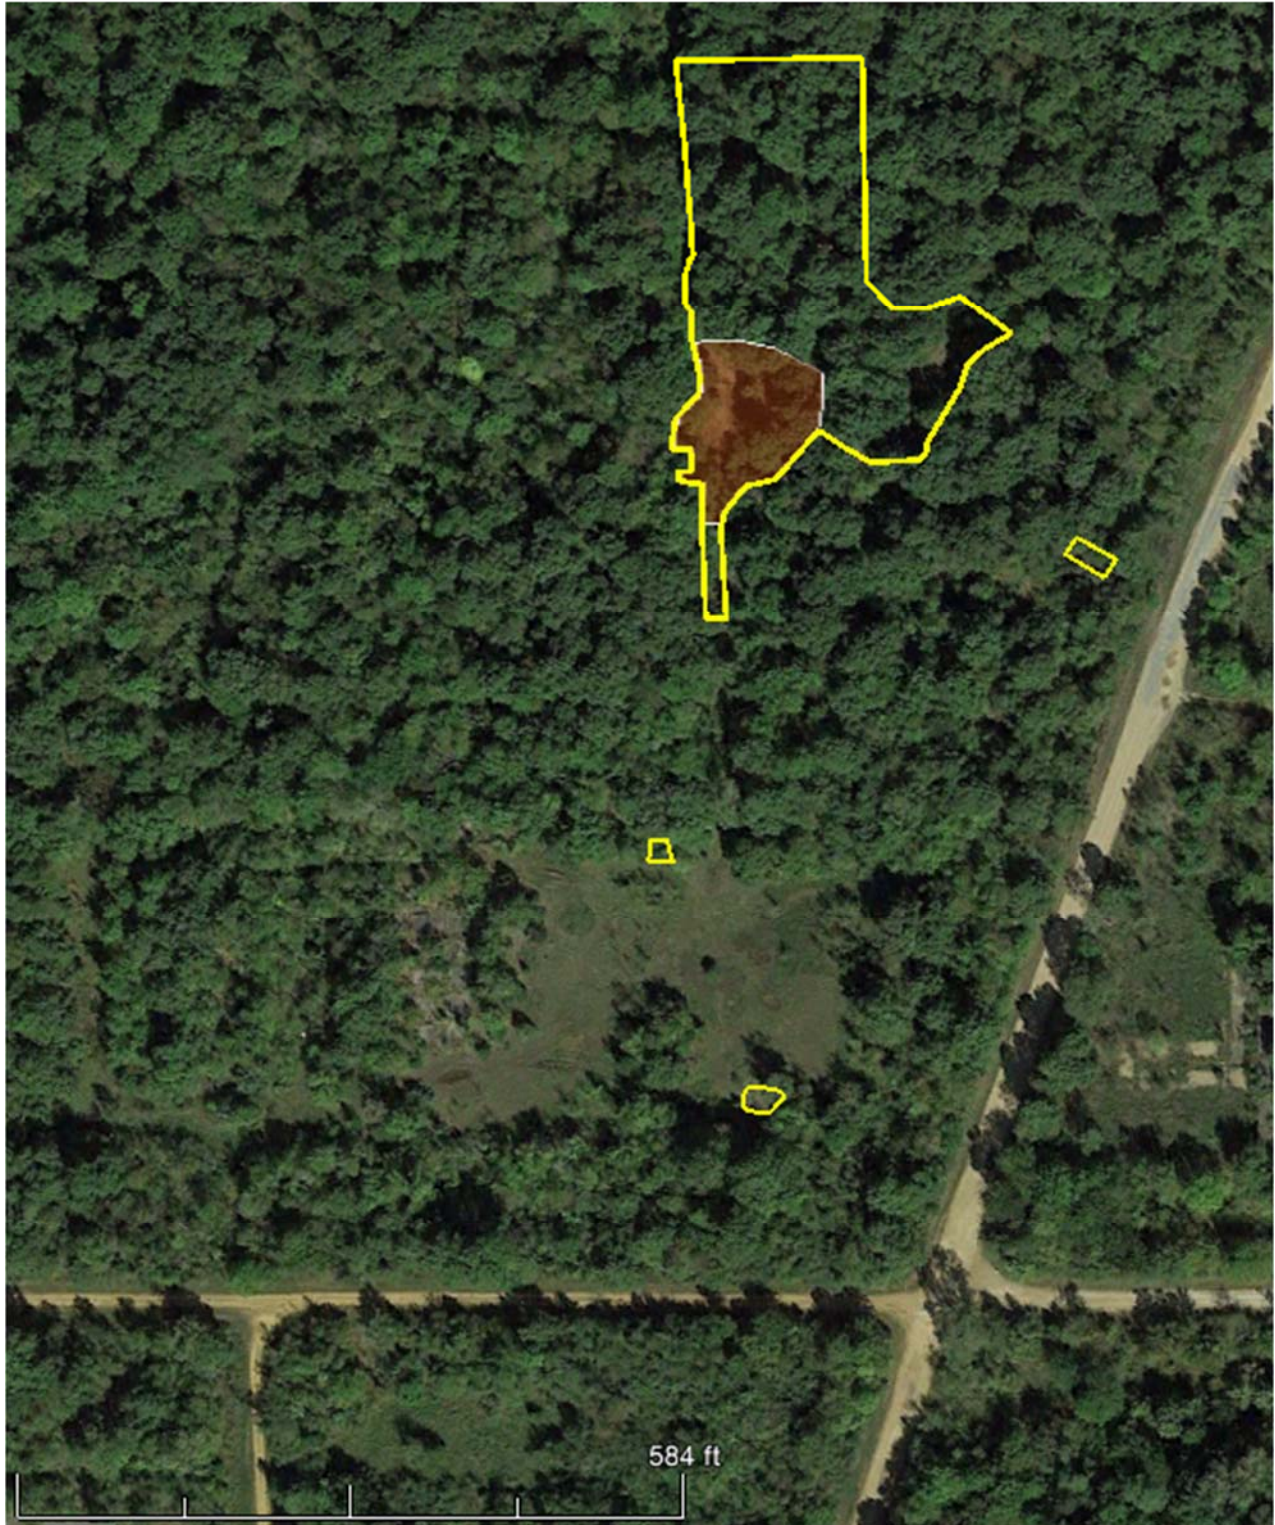
*Yellow outlines indicate the contaminated areas. The brown shading indicates the area considered to be a hazardous waste.*

Status: During early 2020, SFB collected samples of the contaminated material to determine if the material is a hazardous waste. One portion of the largest burn area was found to be hazardous. The hazardous material will require pretreatment with an additive so it can be disposed of in a sanitary landfill, a cheaper alternative than transporting the material to an out-of-state hazardous waste landfill. The Branch is currently working with Kentucky Fish & Wildlife officials to determine any special conditions that must be followed during soil removal within the wildlife management area. Bid specifications for the removal will be prepared once any special conditions have been determined.

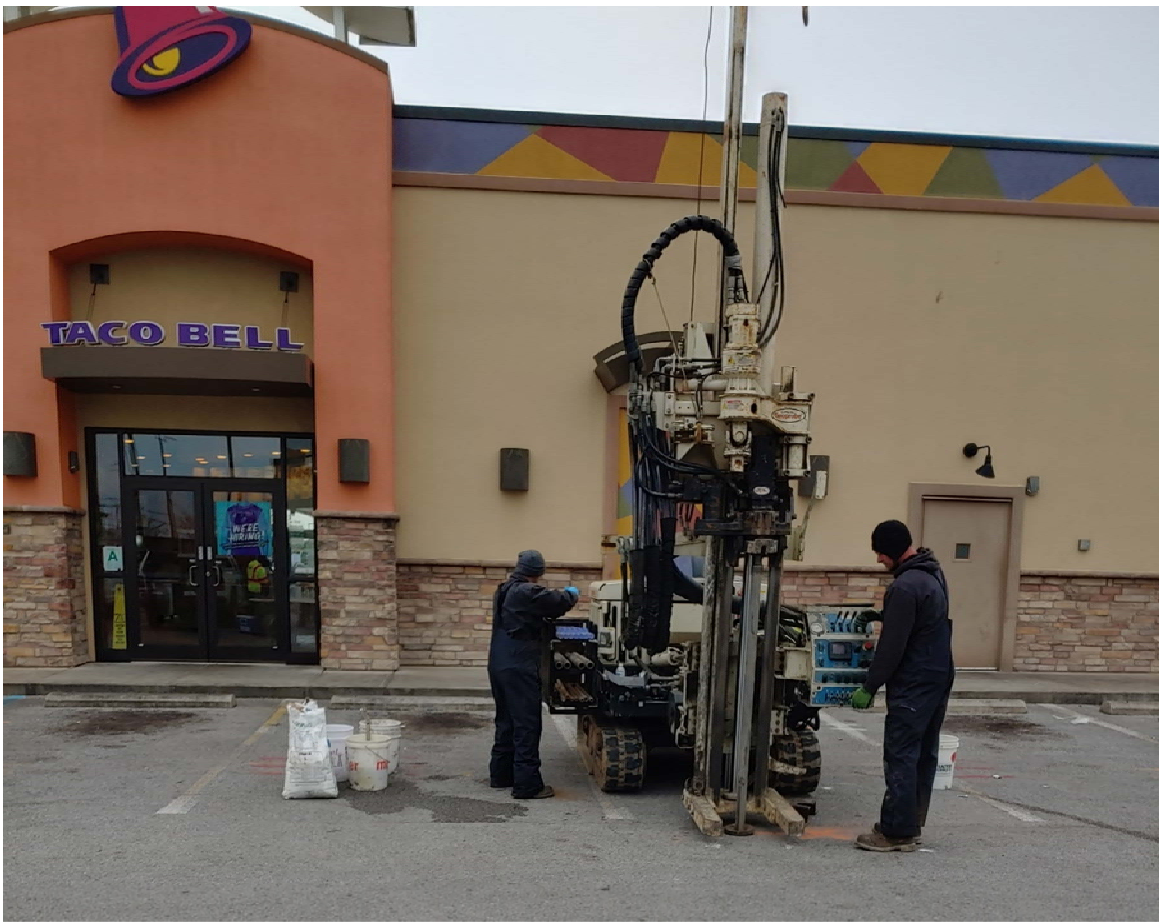
*Wood's drilling subcontractor advancing a soil boring to also serve as a temporary groundwater assessment well. A previous dry cleaning business was razed during the early 2000s. The current owner redeveloped the property based on a site-specific property management plan.*

Status: Wood began the assessment of the first site (formerly Kim's Dry Cleaners) during April 2020. Soil and groundwater samples were collected at nineteen (19) locations. The laboratory analysis is still pending. However, field screening and visual evidence detected the presence of chlorinated (dry cleaning solvent) and petroleum compounds. The property was used for a filling station prior to the dry cleaning operations.

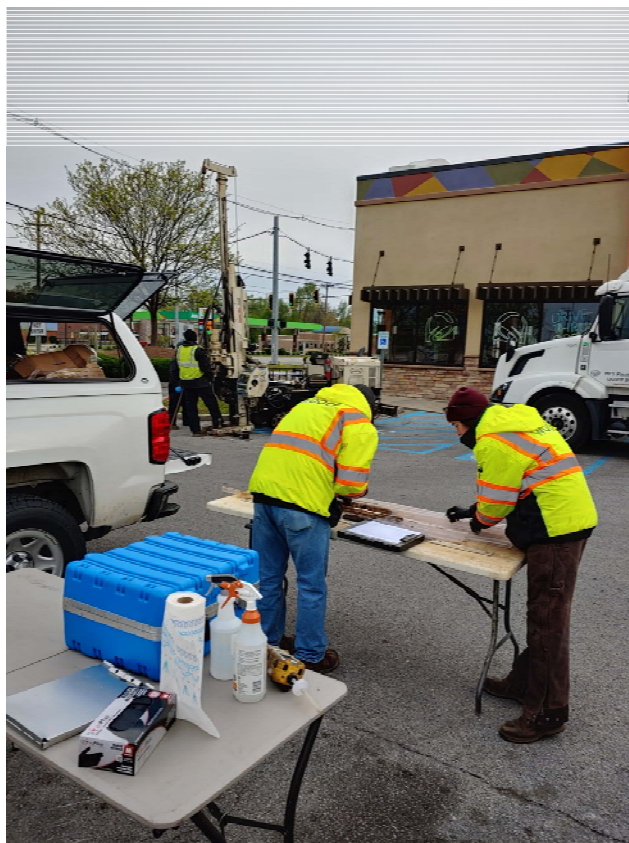
*Wood personnel examining the soil cores as the drilling subcontractor works in the background.*

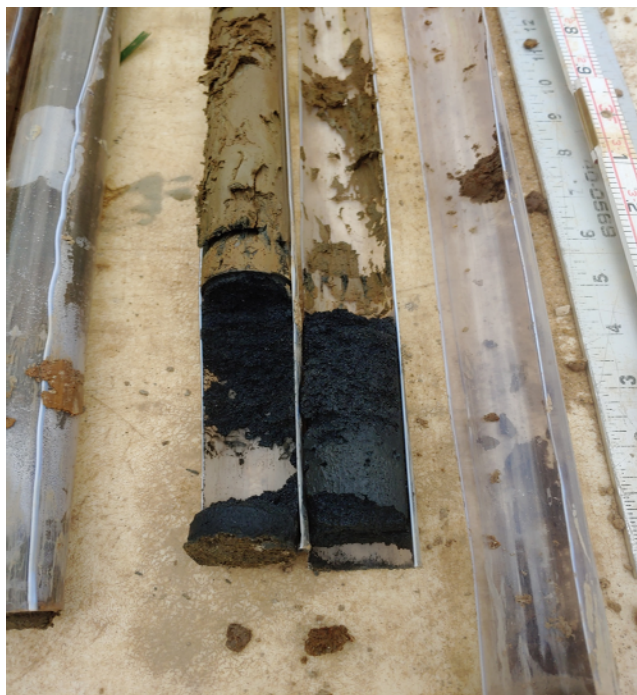
*Evidence in Geoprobe sample of petroleum release.*

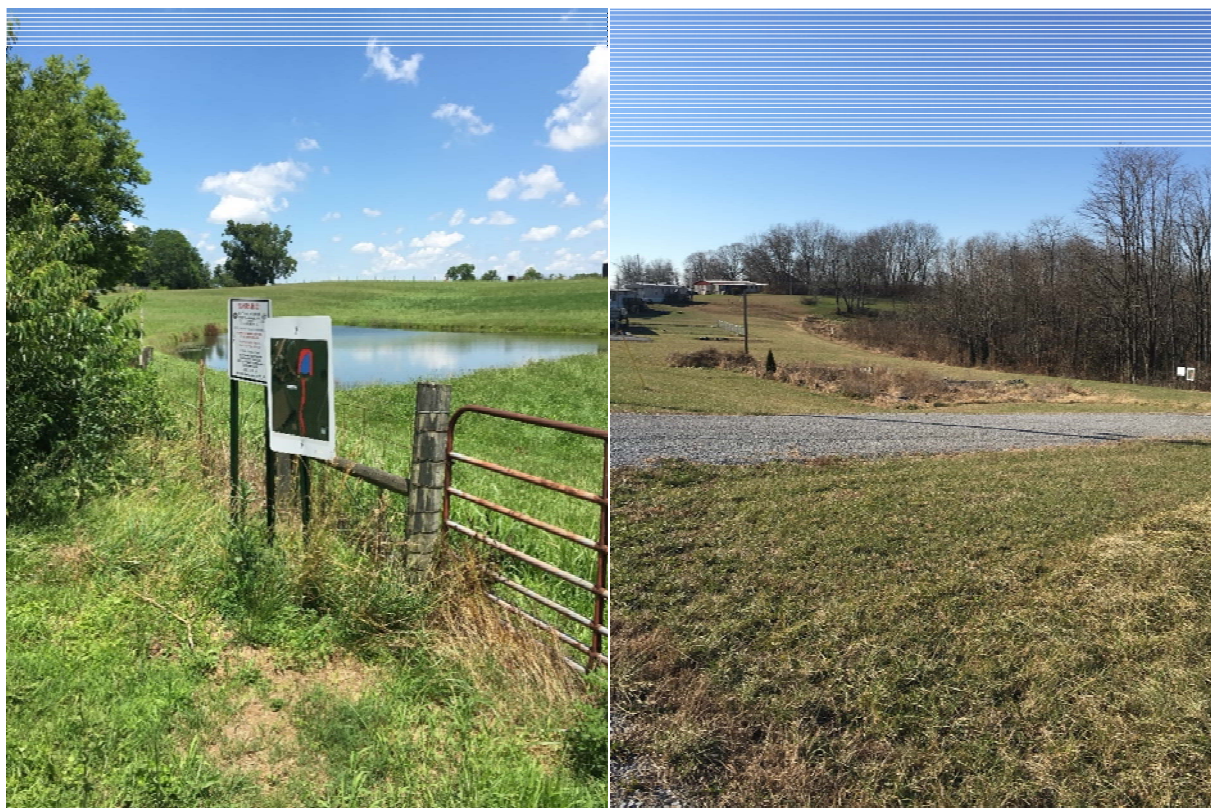
*Signs placed at various locations at the site to warn of potential exposures.*

**October 2019.** Signage was placed on and around the outlying areas that have been assessed for elevated levels of Arsenic. These signs were placed in strategic locations warning of possible exposure risks to the public.

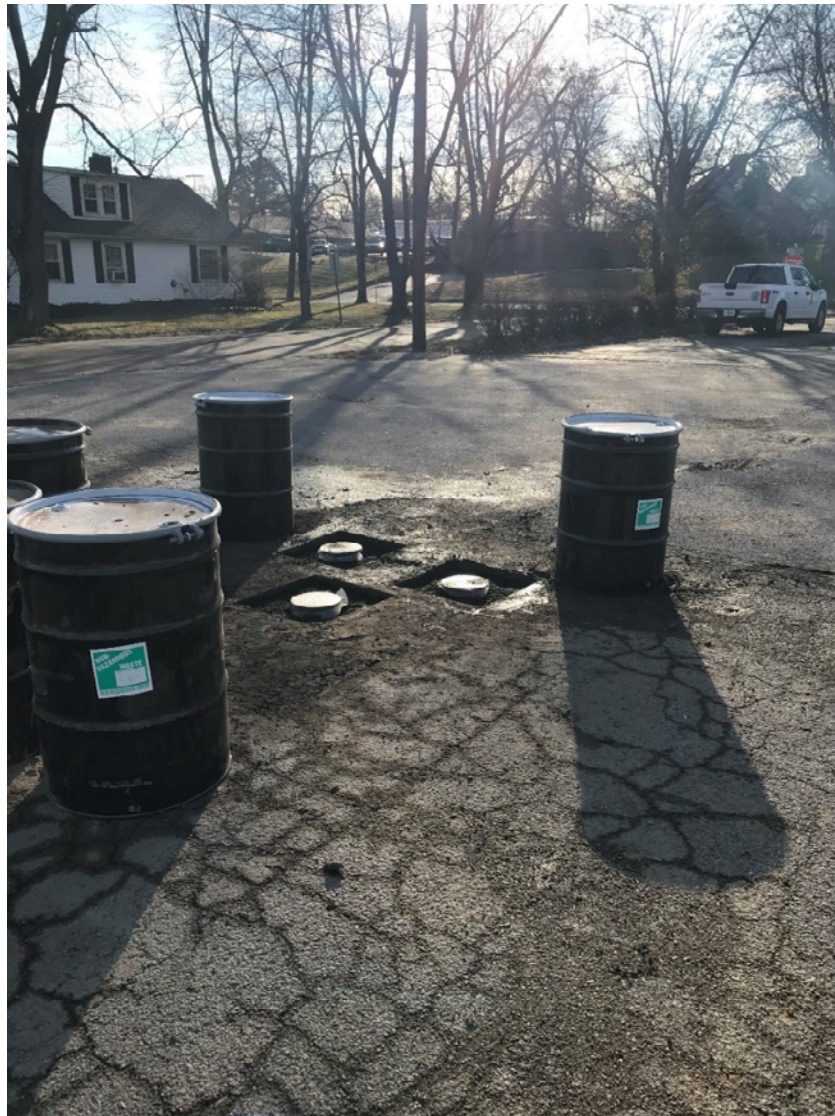
*Nested Wells at Parrish Avenue to monitor three groundwater zones. Drums are cuttings to be disposed.*

The SFB is gathering groundwater data to determine TCE/PCE concentrations in the wells. The extent of groundwater contamination has been defined and groundwater monitoring or corrective action may be requested in the FY2021-2022 budget cycle.

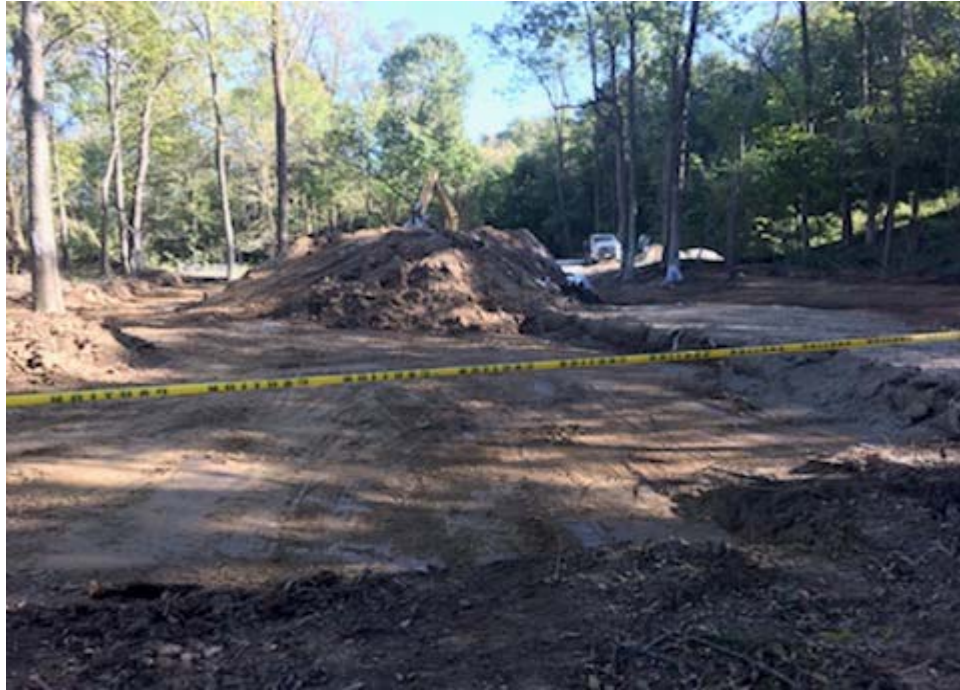
*Stockpiling of soil in the pond area for soil amendment before removal.*

Removal of the 1ft areas outside of the pond was completed on 10/24, 10/26, and 10/30 of 2018. Six hundred and ninety-two (692.77) tons of impacted soil was removed from the site and disposed of at the Owensboro landfill under the guidance of Chase Environmental and the Madisonville Regional Office. Concentrations of sample results post-removal range from 10.6-667 mg/kg. There were 44 samples collected, and only one sample exceeded the residential limit as a composite sample from the east 1ft removal area. Adjacent grab samples (B-33, B-31, and B-26) collected in this same area were all below the residential limit by several orders of magnitude. The only explanation is that perhaps material came off the loading area during sampling collection and caused a spike that is not representative of the site conditions as a whole.

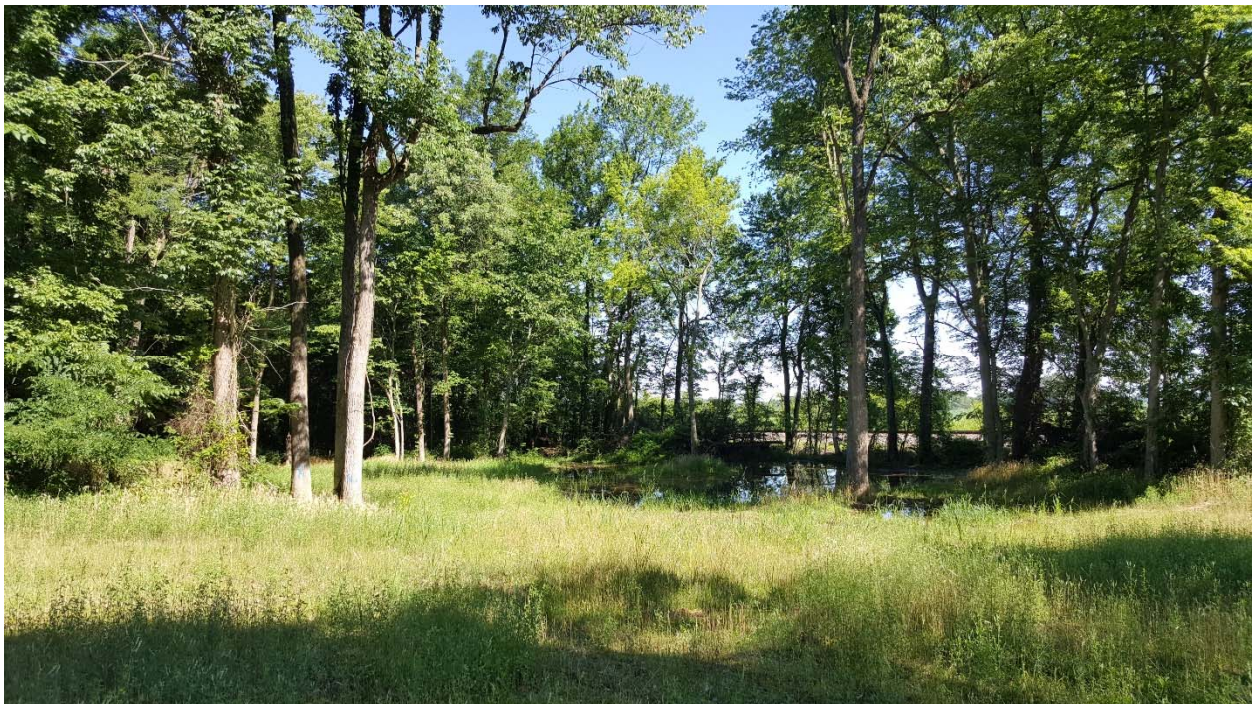
*Site conditions post-removal spring 2019.*

The site was backfilled, seeded, and the temporary road removed. Additional road repairs had to be conducted on Resinerg Road due to impacts by the Tri-Axel dump trucks leaving the site. Total

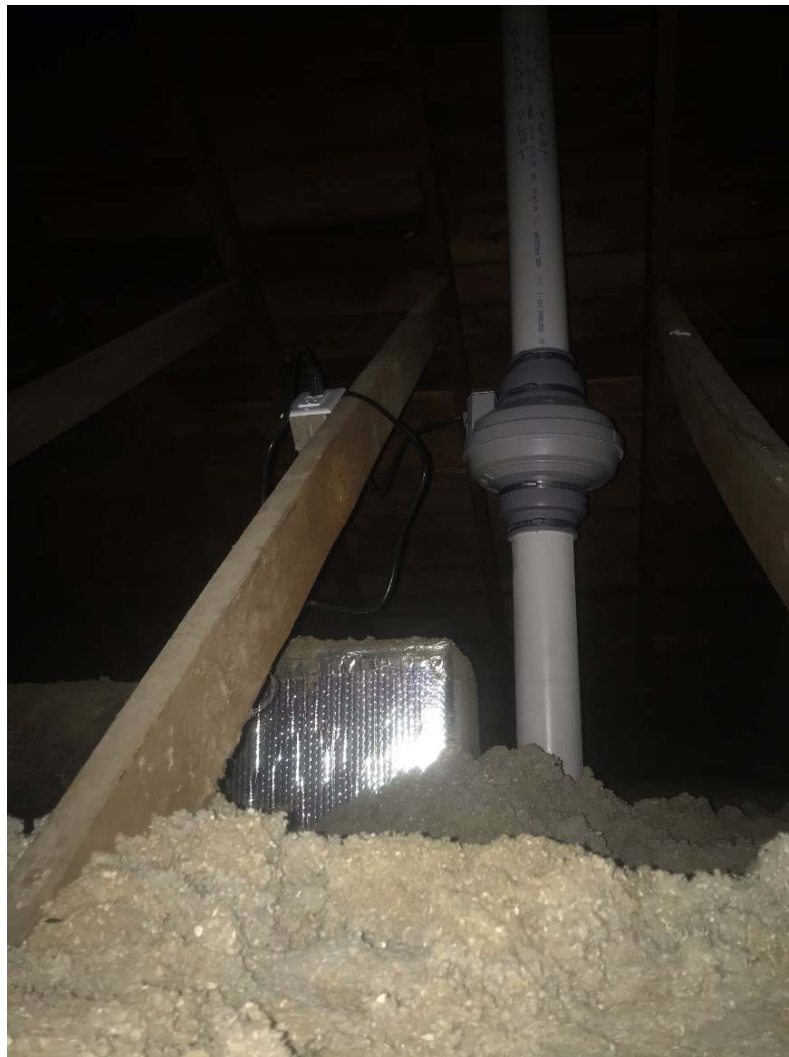
*Leitchfield Cleaners -Vent line and vacuum routing vapors through the attic.*

As a result of these findings concerning significant impacts to soil, sub-slab, and indoor air vapor, and their associated observed levels, it was necessary for SFB to implement emergency abatement procedures to mitigate the immediate vapor exposures to residents living in the apartment building and eliminate any further on-going human health exposures from this release. The financial

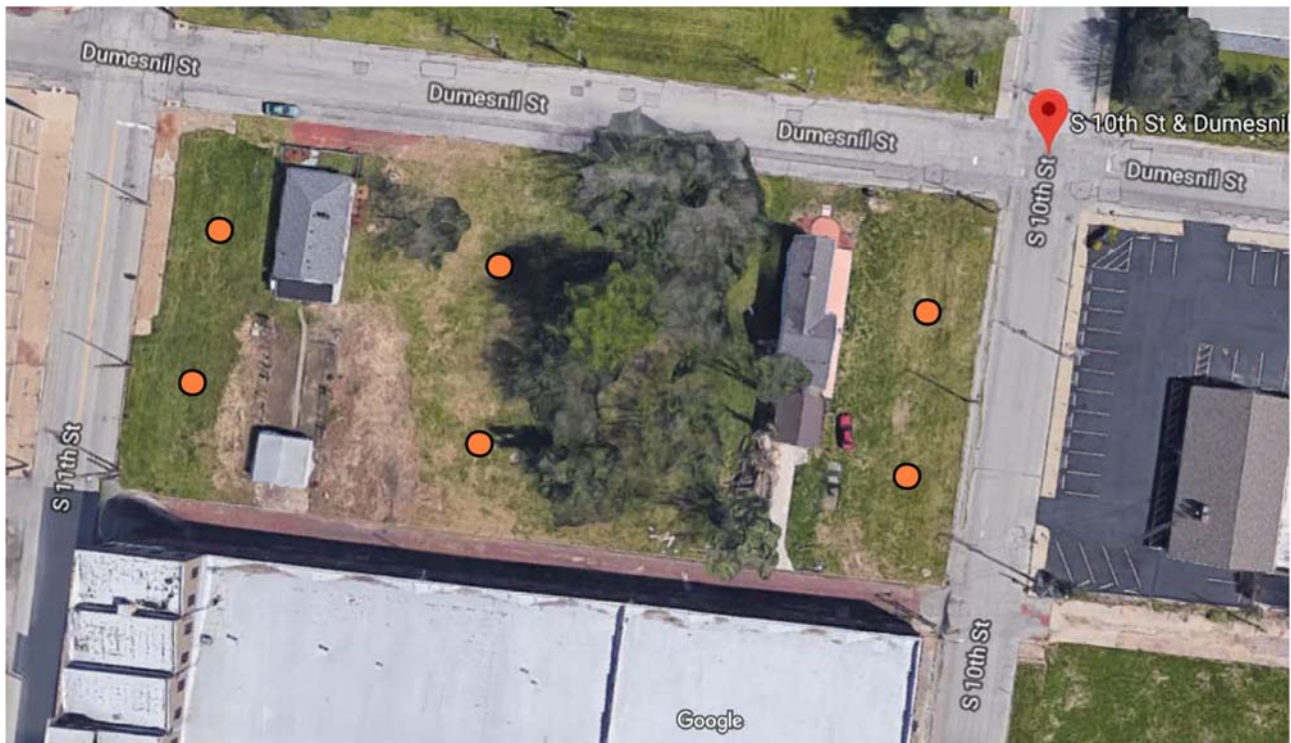
*Aerial view of two residential structures and soil vapor probe locations. The former Henry Vogt facility is south (located below the bottom of this photo) of these residences.*

Status: Although the March 2020 sampling did not indicate a risk for soil vapor intrusion, the vapor probes will be resampled during 2020. The additional sampling will determine if any seasonal variation results in an increased potential for vapor intrusion.

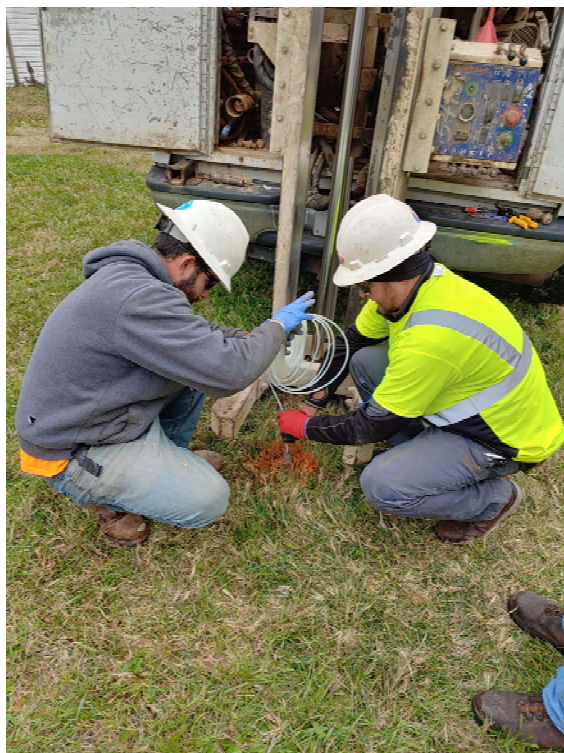
*Soil vapor probes installation. Vapor inlet screen installed 15 feet below the surface. Flexible tubing attached to probe and extends to surface. Steel box and concrete pad constructed to protect tubing.*

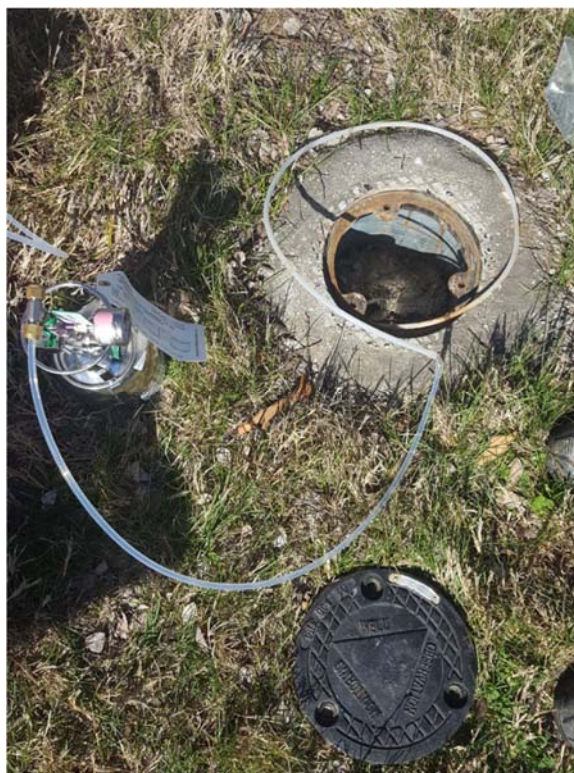
*Vapor sample collected from a soil vapor probe. Summa canister (left) under vacuum that is used to extract soil vapor from probe via flexible tubing.*
